DEPARTMENT OF TRANSPORTATION**DIVISION OF ENGINEERING SERVICES**

Office of Structural Materials

Contract #: 04-0120F4Cty: SF/Ala Rte: 80 PM: 13.2/13.9File #: 69.28**WELDING INSPECTION REPORT****Resident Engineer:** Siegenthaler, Peter**Address:** 333 Burma Road**City:** Oakland, CA 94607**Report No:** WIR-017510**Date Inspected:** 29-Sep-2010**Project Name:** SAS Superstructure**OSM Arrival Time:** 1900**Prime Contractor:** American Bridge/Fluor Enterprises, a JV**OSM Departure Time:** 700**Contractor:** Zhenhua Port Machinery Company, Ltd (ZPMC), Changxing Island **Location:** Shanghai, China**CWI Name:** See below**CWI Present:** Yes No**Inspected CWI report:** Yes No N/A**Rod Oven in Use:** Yes No N/A**Electrode to specification:** Yes No N/A**Weld Procedures Followed:** Yes No N/A**Qualified Welders:** Yes No N/A**Verified Joint Fit-up:** Yes No N/A**Approved Drawings:** Yes No N/A**Approved WPS:** Yes No N/A**Delayed / Cancelled:** Yes No N/A**Bridge No:** 34-0006**Component:** Tower and OBG Components**Summary of Items Observed:**

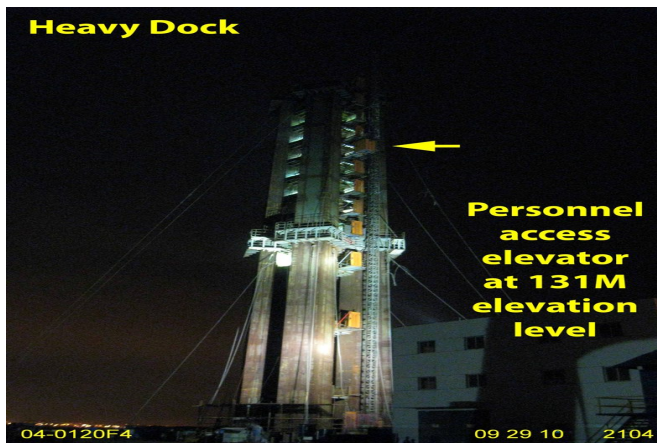
All 4 towers' lift 3 were connected and positioned vertically on a base pedestal at end of the Heavy Dock. East, south, west, and north towers, lift 4 were positioned on top of east, south, west, and north towers, lift 3, respectively, on the Heavy Dock. The personnel access elevator made several stops at 131M, 139M, and 143M elevation levels and sounds of drilling could be heard from the deck of the Heavy Dock. The ZPMC 1300 ton floating crane was moored to the Heavy Dock and sitting idle.
